United States Department of Agriculture
Agricultural Research Administration
Bureau of Entomology and Plant Quarantine

+ INSTALLATION OF WINDOWS IN PANELS OF A SEDAN DELIVERY TRUCK
U. S. DEPARTMENT OF AGRICULTURE

By O. E. Berndt

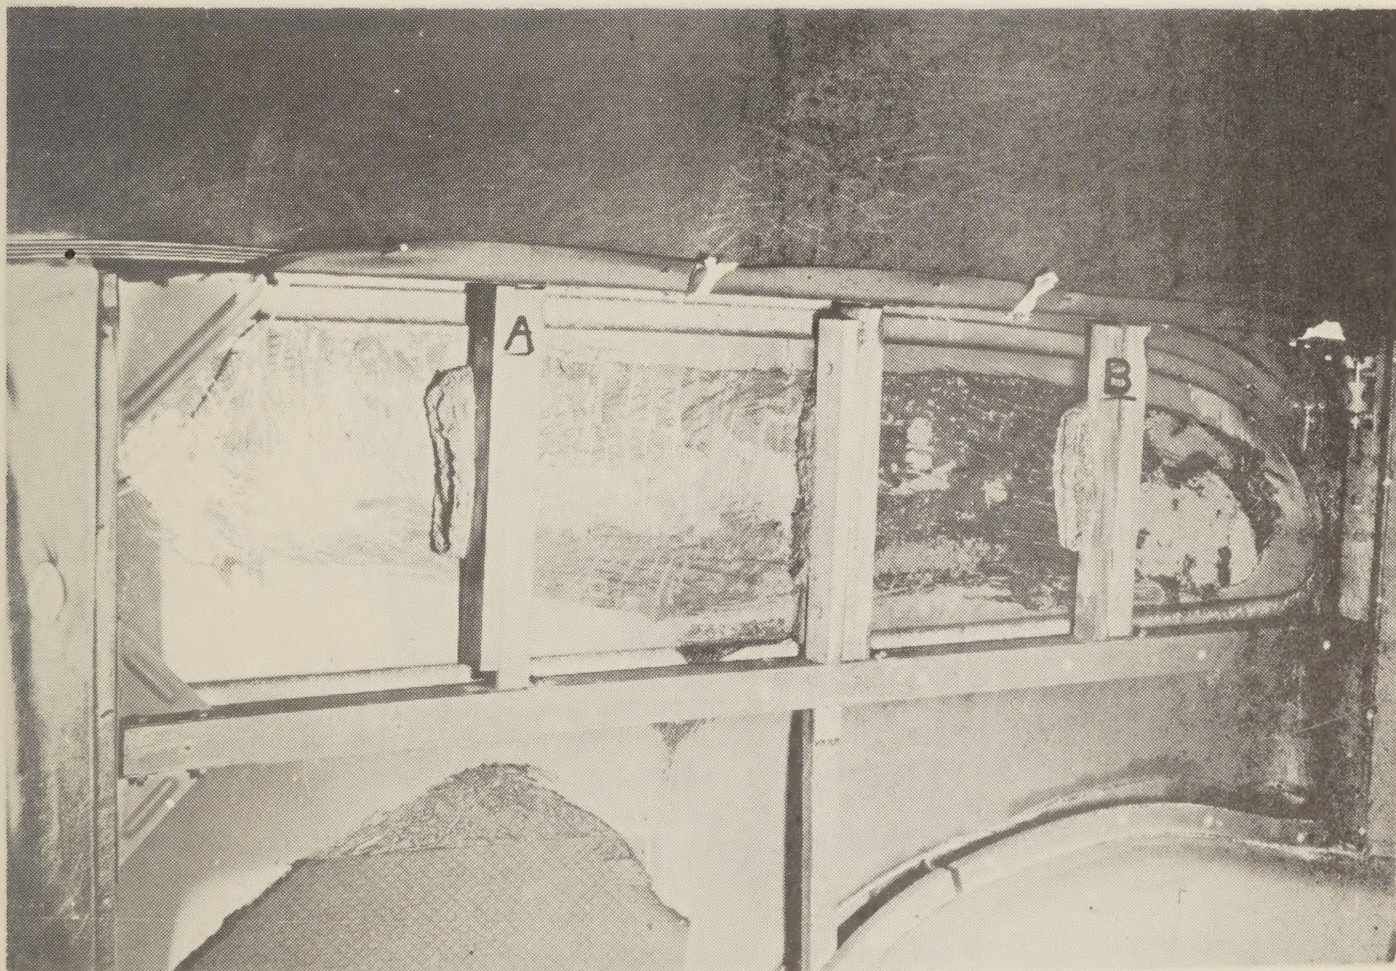
Figure 1.--Interior view of truck showing fiberboard removed, exposing side wall bracing. Struts A and B are removed to permit window installation.

The inside fiberboard wall covering the framework of the car is first removed to expose the bracing members as installed at the factory. The two struts A and B in figure 1, lateral of the center strut, are then removed.

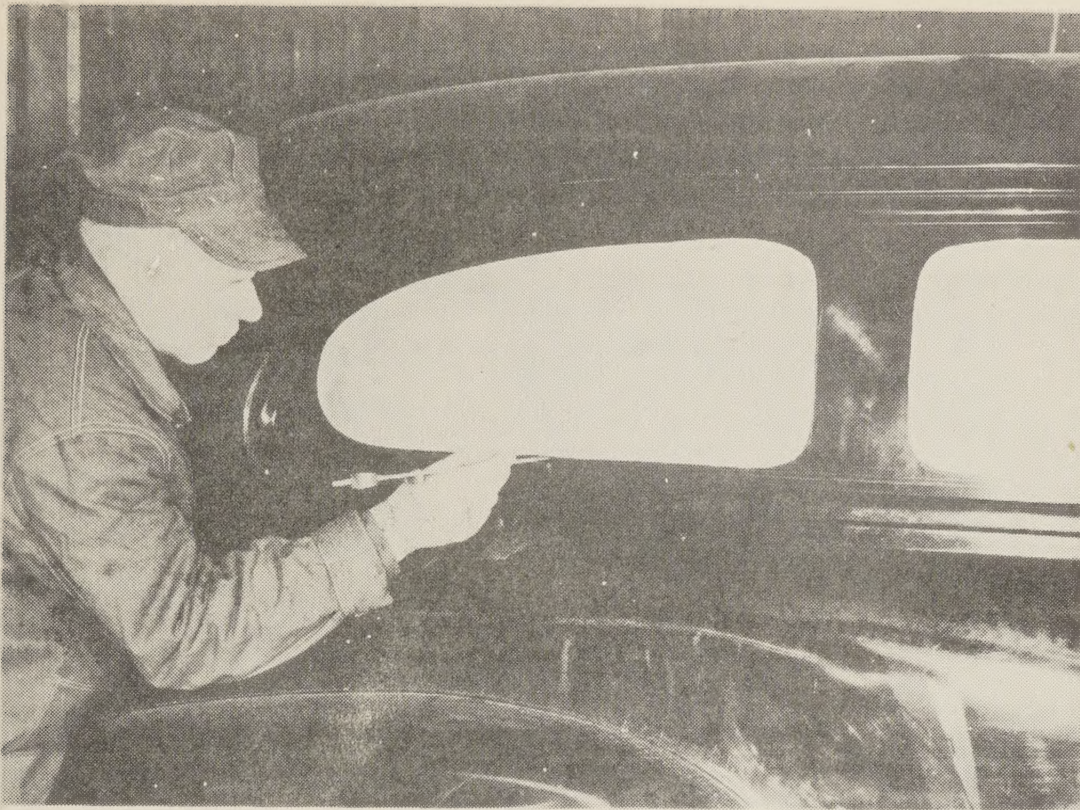
Figure 2.—Exterior view of truck, showing paper template attached to panel surface. Scriber is drawn around edge of template to mark cutting line.

A paper template is made and pasted on the outside surface of the panel in the position in which the windows are to be cut. The template follows as nearly as practical the contours of the panel. A 1-inch margin was left between the edge of the template and the edge of the panel in the truck illustrated. If the panels are larger, a wider margin is allowed in the interest of proper proportioning, appearance and strength. With the template in place, a scribe is used to mark the line of the cut on the metal surface (fig. 2).

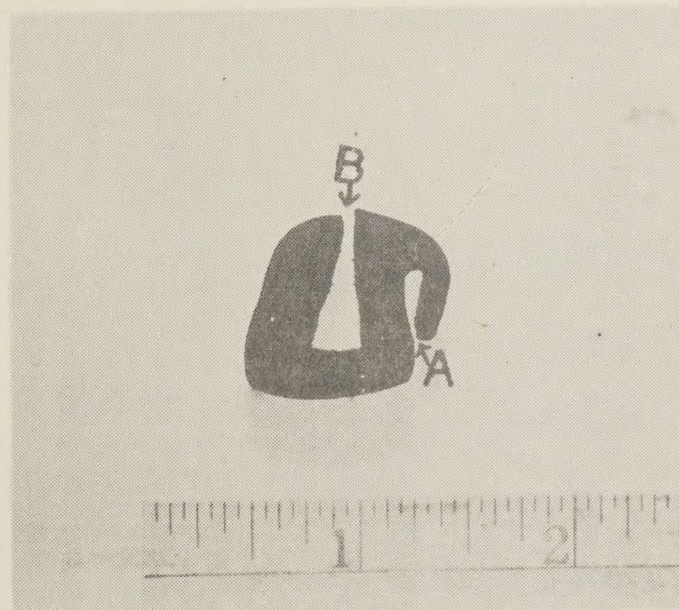
Figure 3.—Cross section of channel rubber, showing grooves in which glass and metal are imbedded.

A strip of channel rubber similar to that commonly used in installing automobile windows is worked over the cut edge of the metal with a screw driver or a similar tool, so that the narrow groove in the rubber fits over the metal edge (fig. 3-A). The rubber strip is cut so that a tight butt joint is made at the top of the window. This joint is later sealed with liquid rubber and sanded until it is practically invisible.

The rubber is then removed and fitted over a glass pane cut to a size $\frac{1}{4}$ inch larger all around than the opening into which it is to be fitted. The pane with its periphery imbedded in the wide groove (fig. 3-B) of the channel rubber is then inserted in the opening with the overlap of the pane on the inside of the panel.

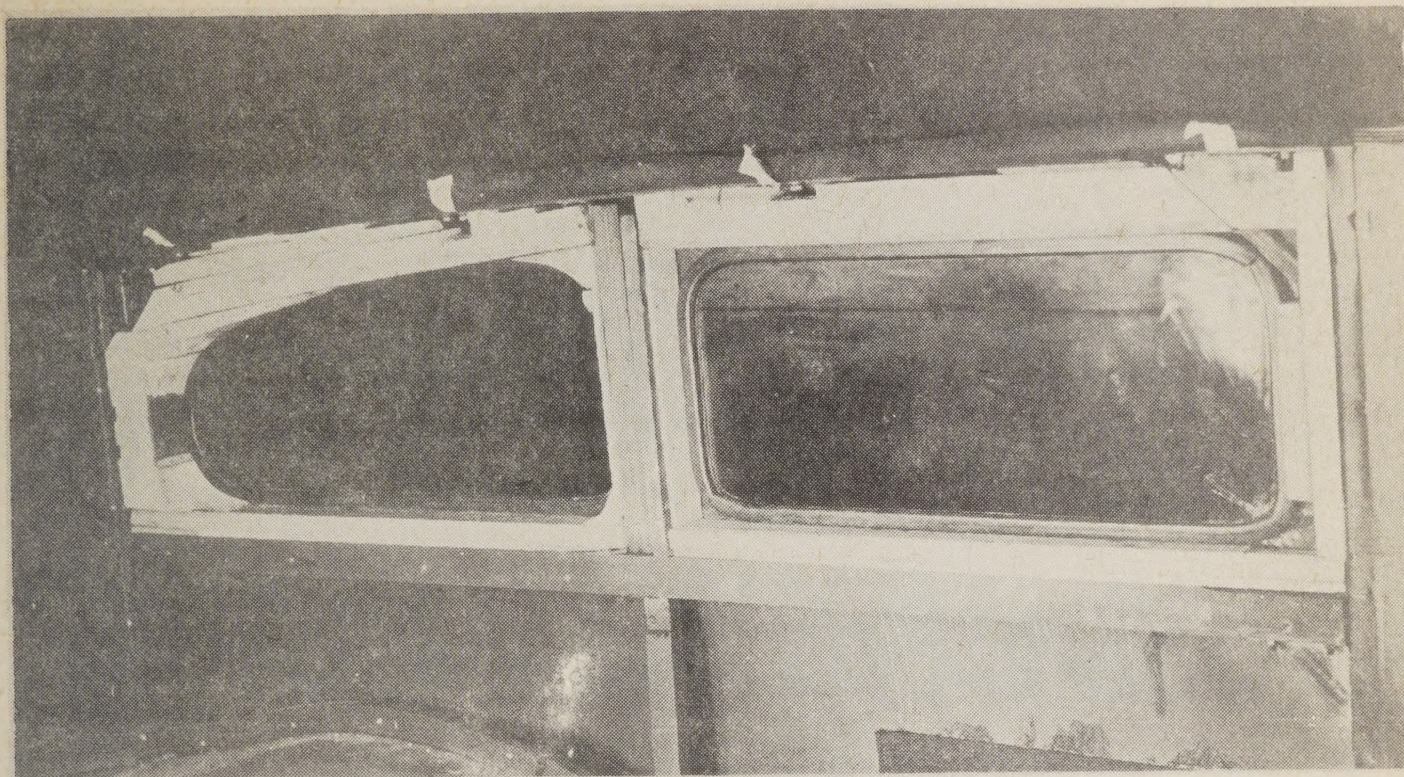
Figure 4.--New casing around rubber on inside of panel to replace bracing and provide solid backing for tacking fiberboard wall and trimming at window sill.

When the pane is in place, the framework of the window is formed with wood pieces fashioned to conform to the contours of the window, and attached solidly with nails and screws to the remaining original supporting framework (fig. 4). The curved corners can be installed most easily by use of short metal strips. A strip of a neutral shade of standard-gage linoleum is fastened to the new framework with small box nails and cut to a width equal to the thickness of the frame (fig. 5). The inside fiberboard wall is then attached in its original position, and the window openings are cut to correspond exactly with the edges of the linoleum strip on the window framework.

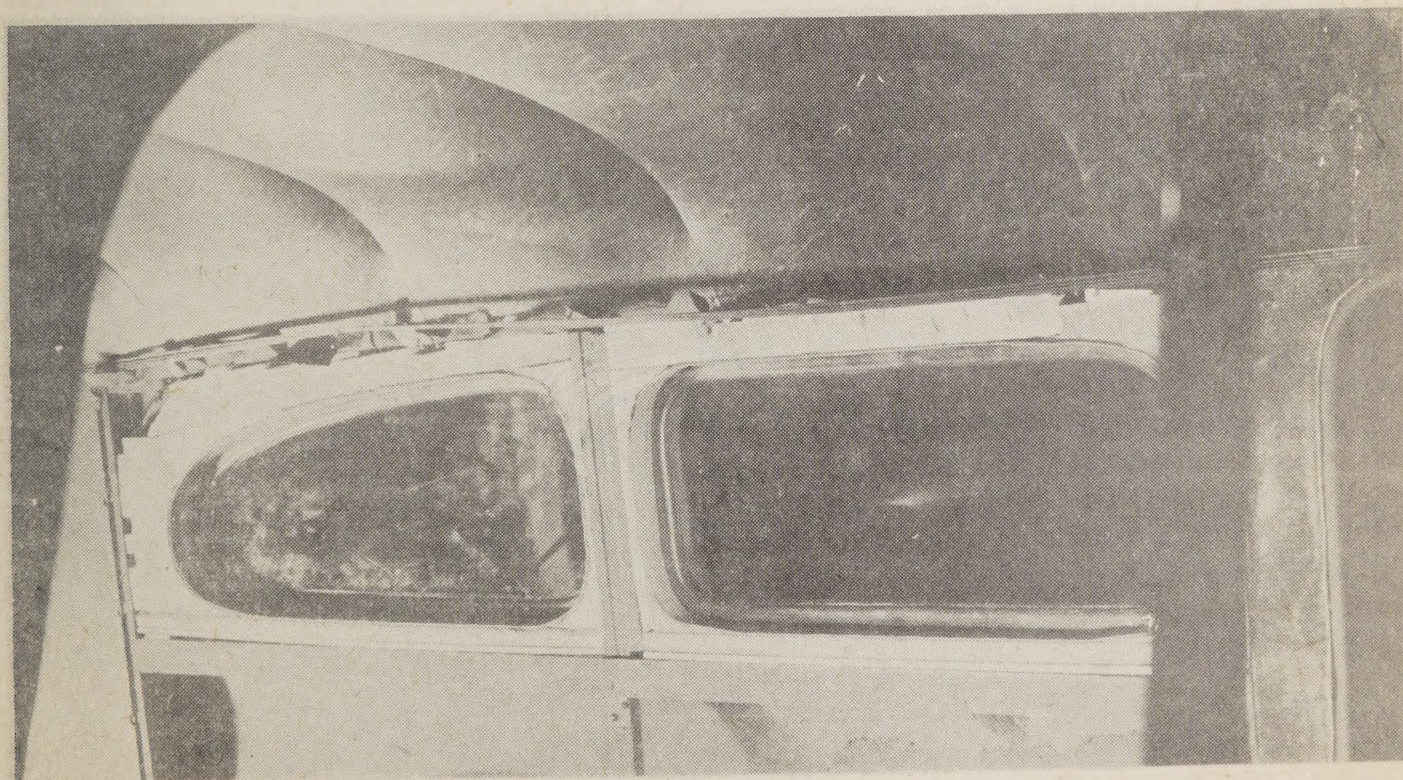
Figure 5.--Completed interior installation, showing casing and linoleum strip in place prior to replacing fiberboard wall.

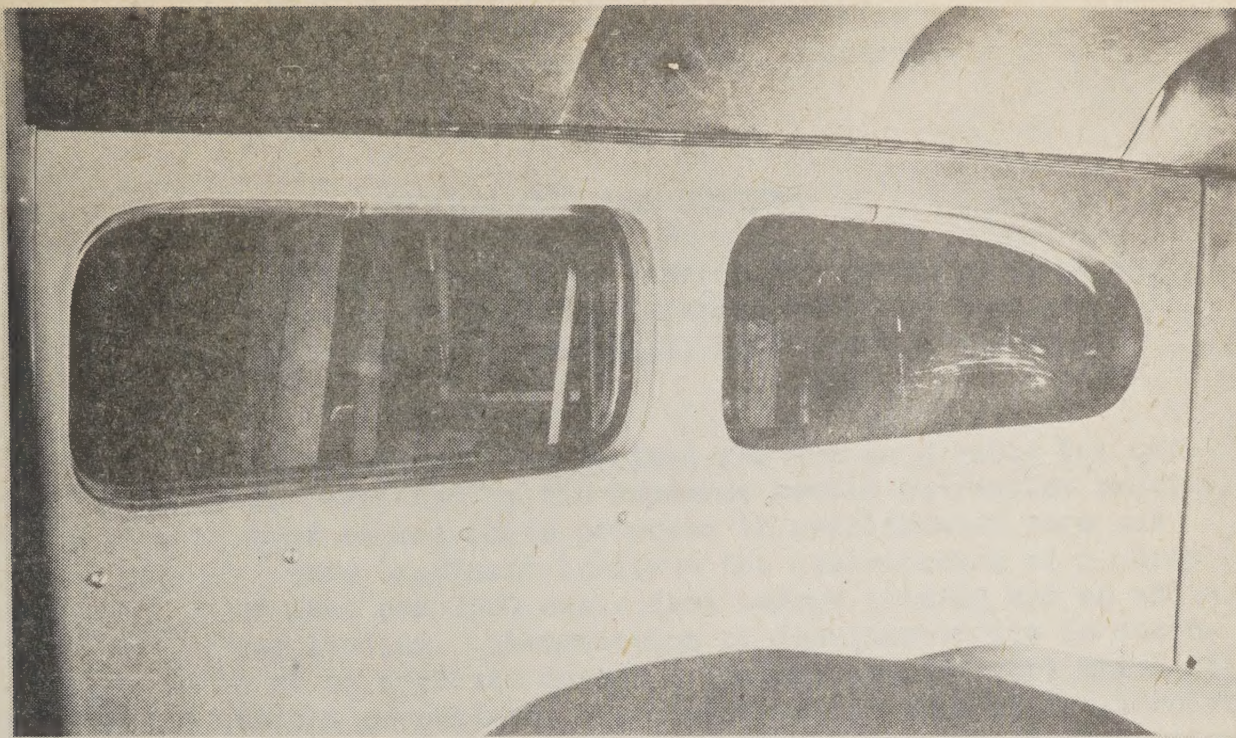
Figure 6.--Interior view showing completed job with fiberboard wall in place and window opening trimmed to sill.

An interior view of the finished job is shown in figure 6, and the exterior appearance of the car with the windows installed is shown in figure 7.

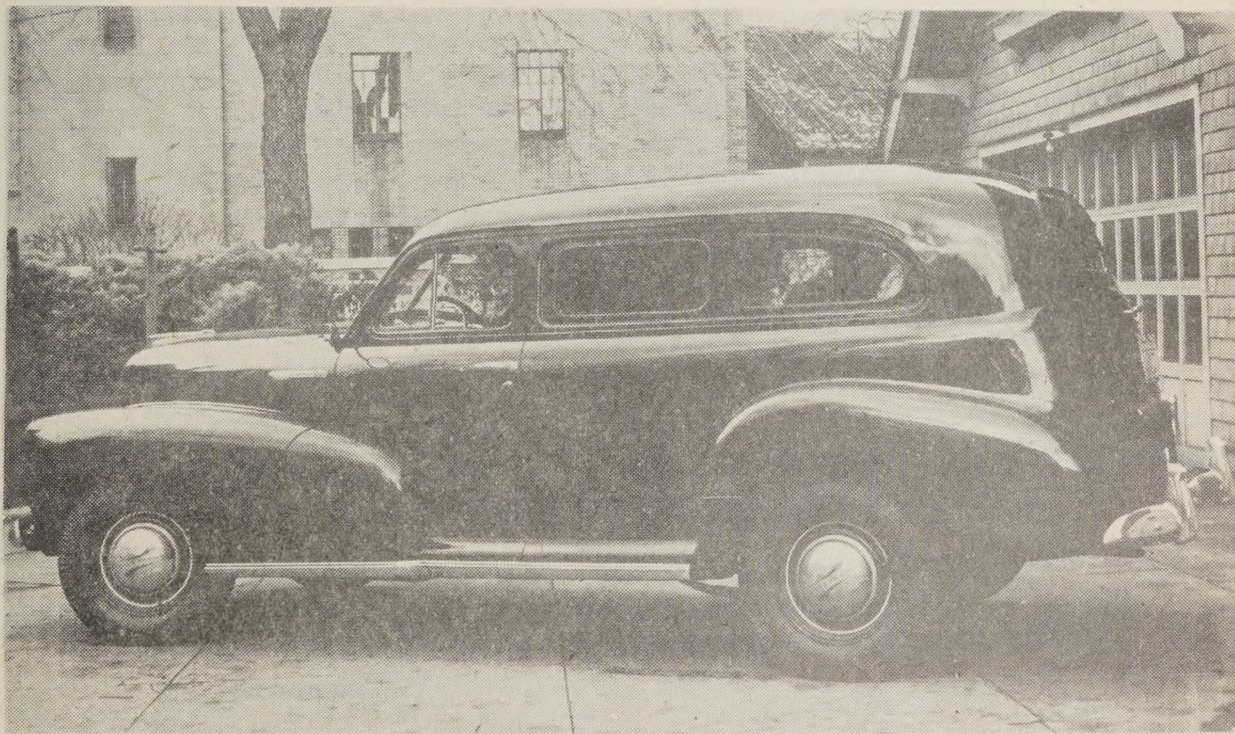
Figure 7.--Exterior view of truck with window installation completed.
